**Documentary Research and Archaeological
Investigations at the Waite-Kirby-Potter Site,
Westport, Massachusetts**

**Prepared for:
The Community Preservation Committee
Town of Westport
Westport, MA**

**Prepared by:
Katharine M. Johnson and Christa M. Beranek
With contributions by Kathryn A. Catlin and Laura W. Ng
Fiske Center for Archaeological Research
University of Massachusetts Boston**

Cultural Resource Management Study No. 37

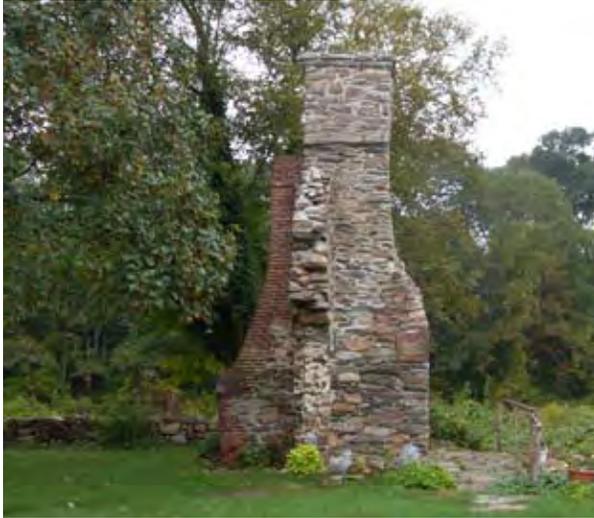
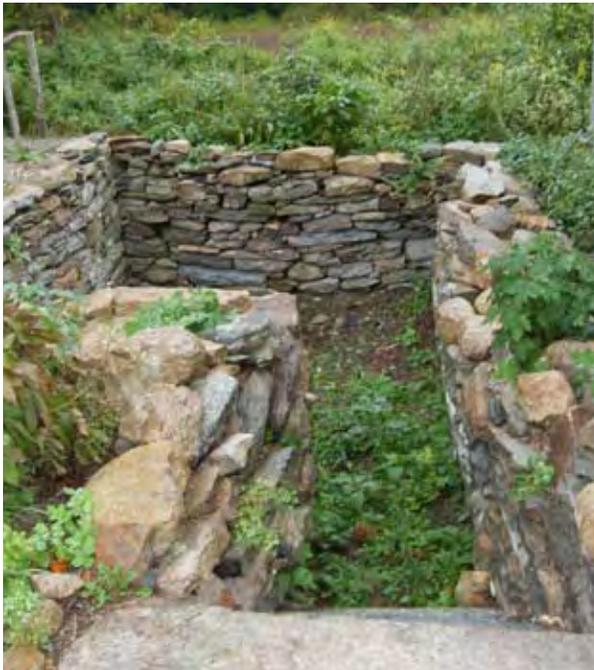
Figure 1.3: Photograph of current conditions. Top) Standing chimneys; Bottom) Open cellar hole east (to the right) of the stone chimney.

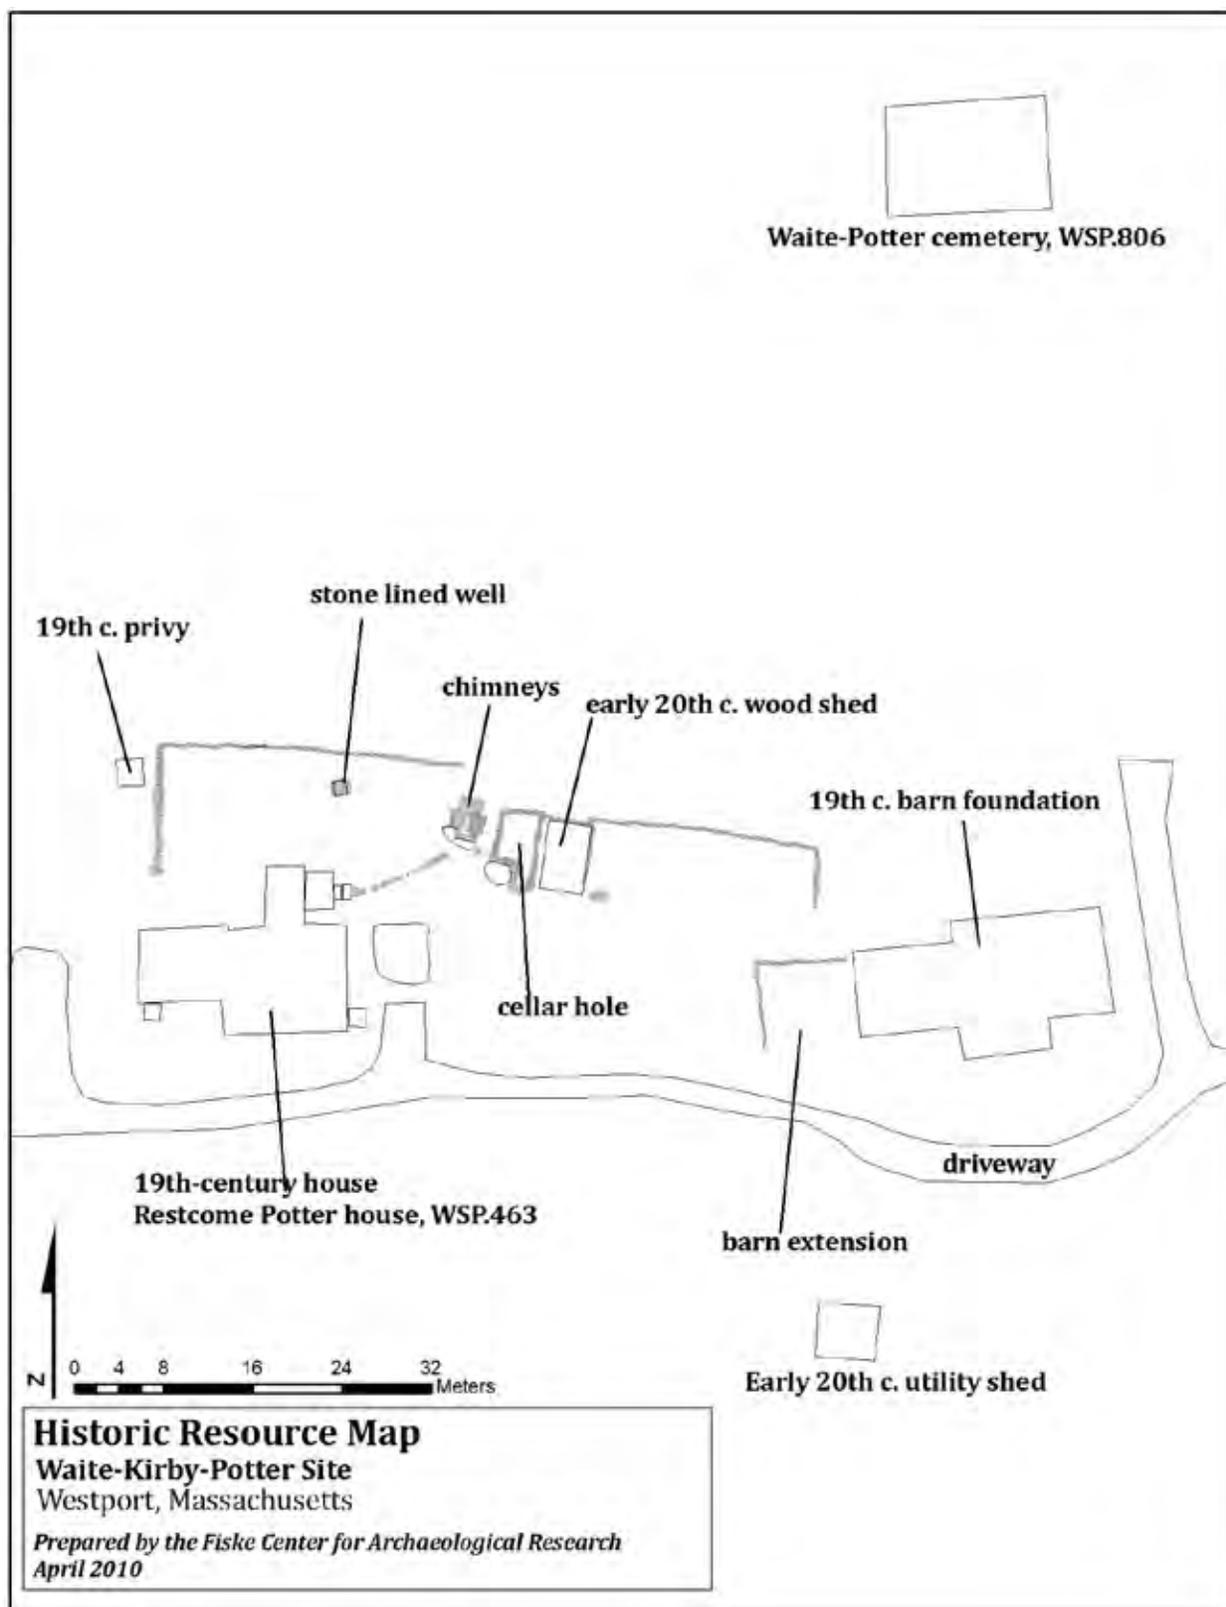
Figure 1.4: Overview of all above-ground cultural resources on property.

property that relate to its use in both agricultural and domestic contexts (Figure 1.4). These include a 19th-century barn foundation, privy (Muriel Bibeau, personal communication, 2009), and the farmhouse mentioned earlier. These elements are integral to the site because they exemplify the continued use of the property from the early 18th century to the present, a common characteristic of many farmsteads in this region.

The survey, in addition to archaeological excavation, included a walkover of a larger area to assess other cultural resources visible on the surface (Figures 1.4 and 2.1). This also included a walkover of the two adjacent plowed fields. Surface features were then mapped using a Topcon single-operator transit and are included in our site plan. This part of the survey was successful in locating and digitally mapping the foundation of a 19th-century barn on the property, as well as the location of an early 20th-century utility shed, and the location of the Waite-Potter burying ground (WSP.806), containing members of the Kirby family.

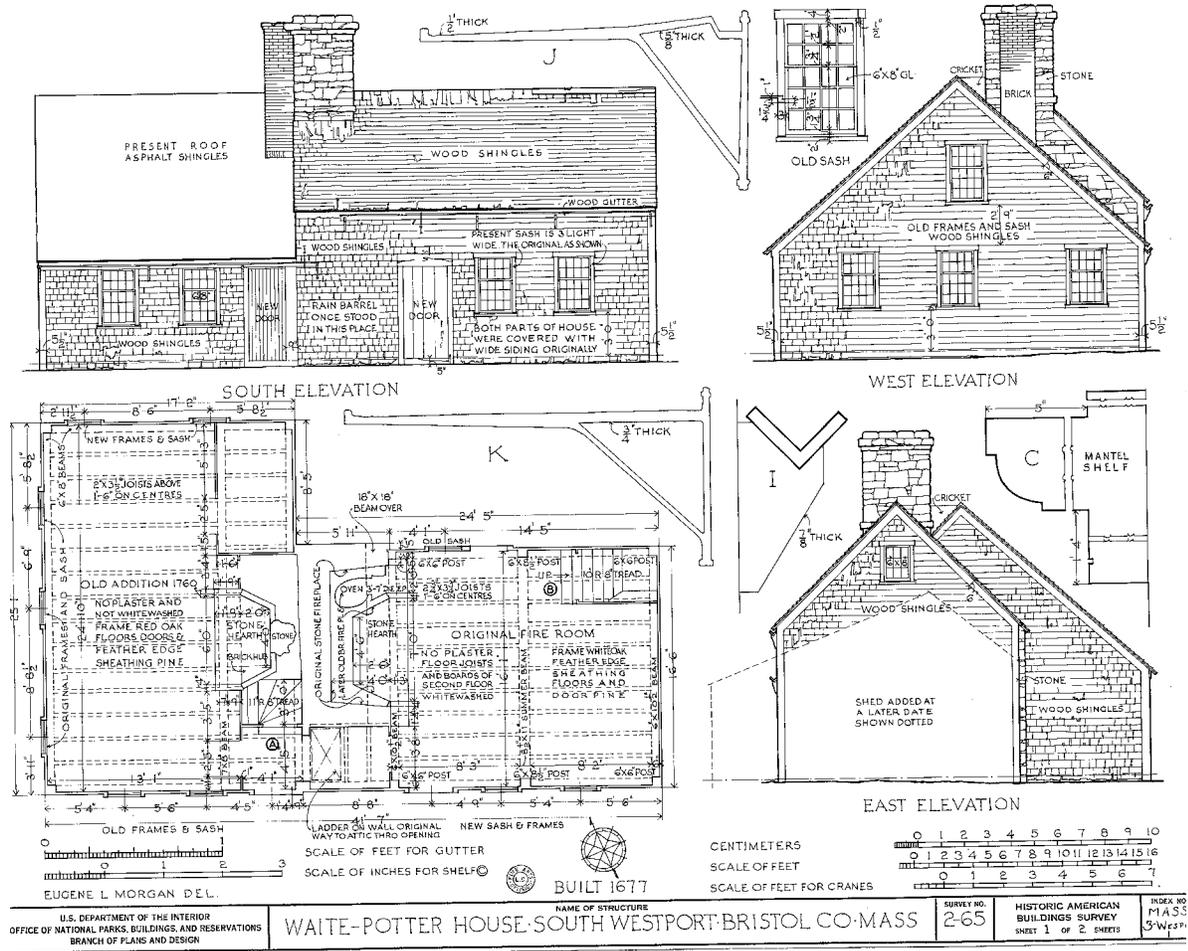
Figure 1.8: 1934 HABS plan of the Waite-Kirby-Potter House (HABS MASS 3, Wespos 1, plan 1 of 2).

In 1934, the house was documented by the Historic American Buildings Survey (HABS) (MA-2-65). The survey noted that the date of construction as 1677, although the available data page does not describe the house in any detail in terms of construction or land evidence. Two architectural drawings were made as well (Figures 1.8 and 1.9). Note that the two windows on the right had been replaced with 9/6 panes. The weathering of the exterior wood is visible next to the protected area where the western entry door stayed open (Figure 1.10). The roof on the 18th-century addition also appears to have been reshingled with asphalt shingles, while the original portion of the house still had wood. These small modifications suggest some minimal repair work to the house.

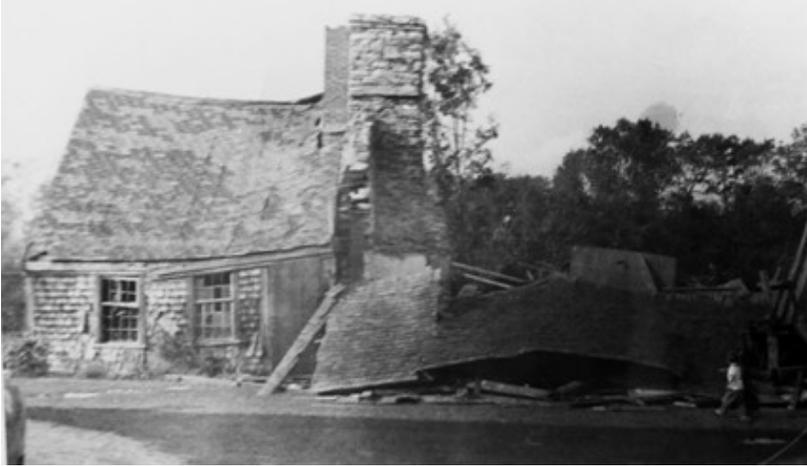
Figure 1.11: Waite-Kirby-Potter house after 1954 hurricane (Courtesy M. Bibeau).

In 1954, the eastern (older) half of the house was destroyed and the western half badly damaged by Hurricane Carol. The western half was taken down between 1956 and 1960 because it was so badly damaged and unstable (Figure 1.11). Some of the wood and other parts of the western half of the house were sold by Alice Potter to Carlton Brownell who at the time was President of the fledgling Little Compton Historical Society in that town just to the west (Muriel Bibeau, personal communication). By the 1950s Carlton was in the process of restoring the 17th-century Wilbor House to become a house museum, and he used many wood planks and doors in the Wilbor House that had once been part of the Waite-Kirby-Potter house (Carlton Brownell, personal communication). For example, large wooden planks now extant in the Wilbor House "long kitchen" were taken from the Waite-Kirby-Potter house's western addition and support the oral tradition that this part of the house may have been used as a workshop (Figures 1.12 and 1.13). At least one object from the house, a wooden chest marked P.G. Potter, also entered the collections of the Little Compton Historical Society (catalog #1979.119).

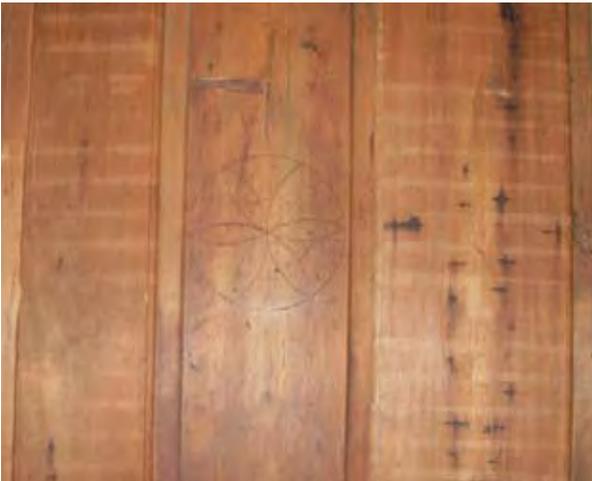
Figure 1.12: Compass carvings and lath/plaster marks on reused board sheathing currently in the Wilbor House in Little Compton, but salvaged from the Waite-Kirby-Potter house in the 1950s. (Courtesy Little Compton Historical Society).

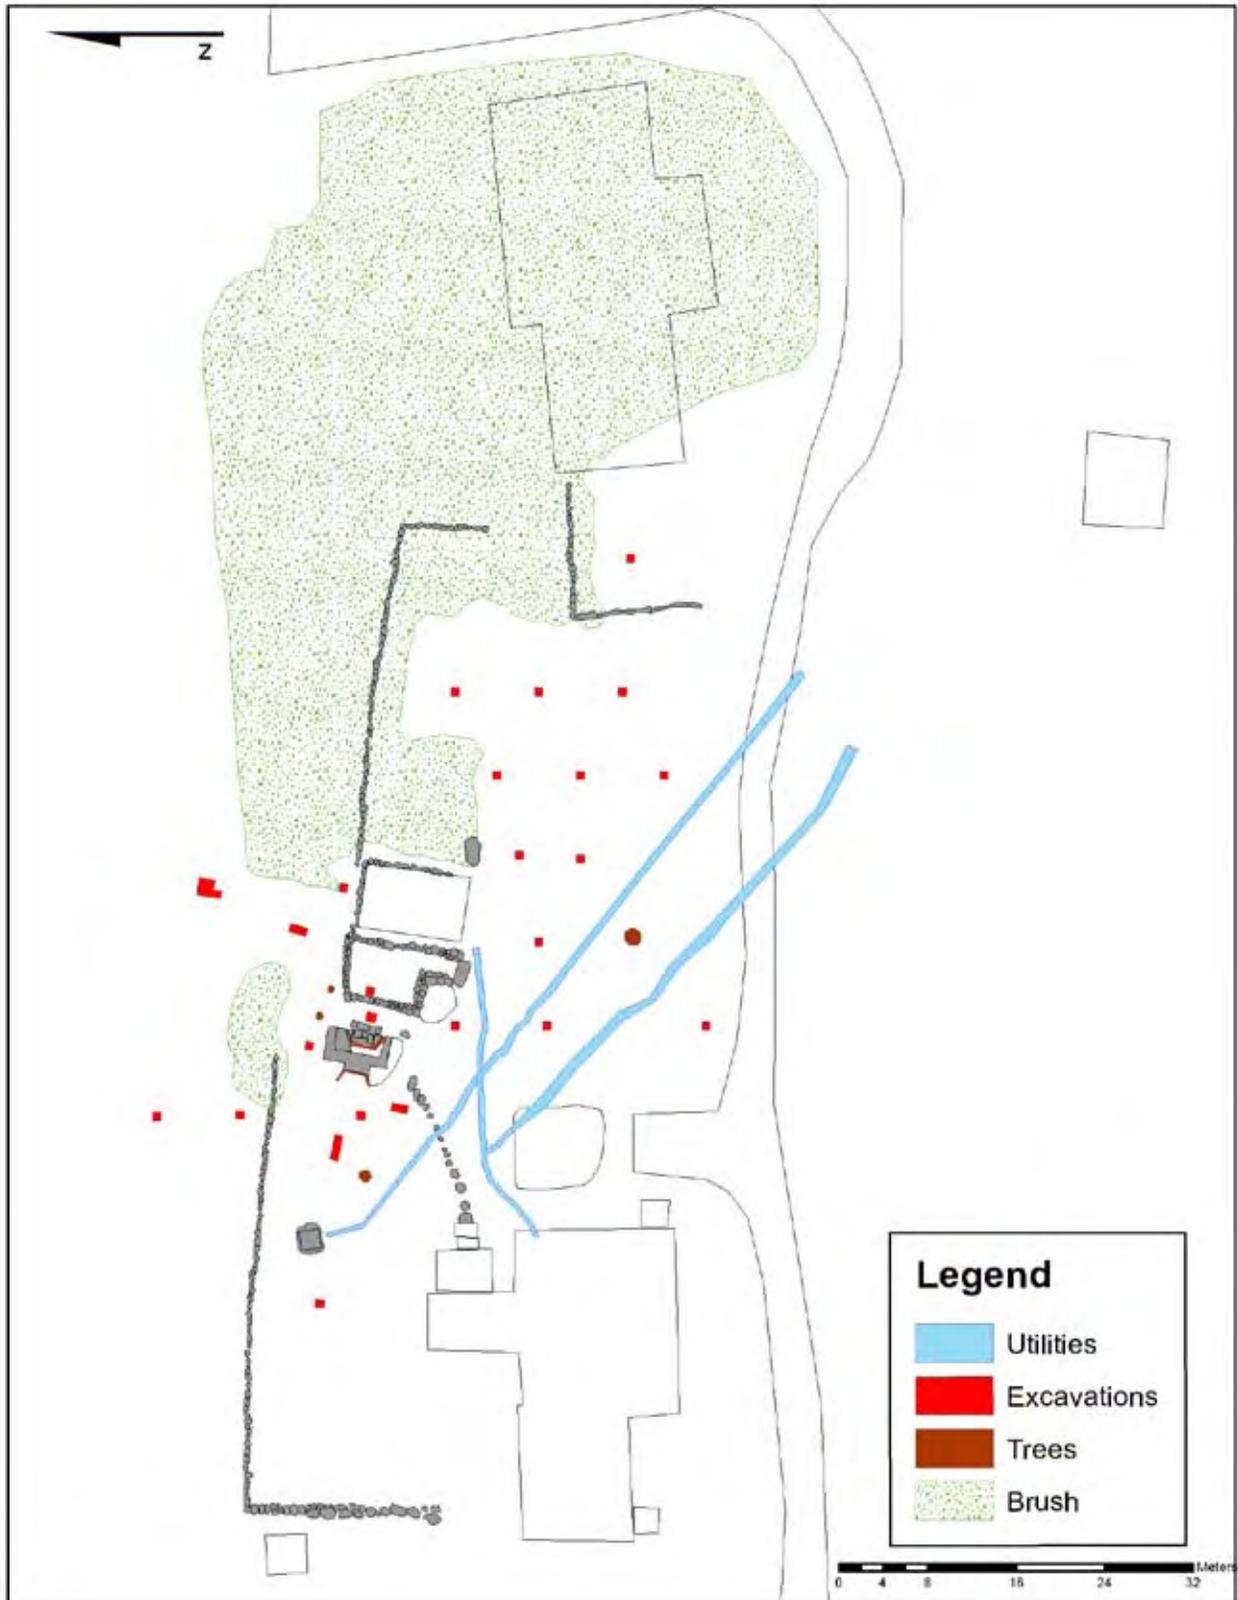
Figure 2.1: Map of excavation areas, utilities, surface conditions, and historic structures.

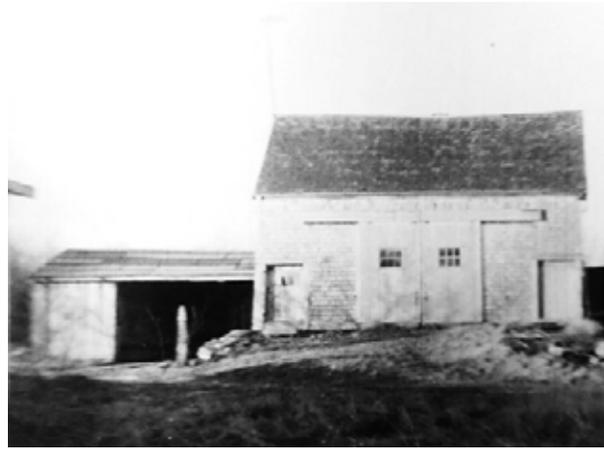
Figure 3.18: 19th century barn. Only the foundation remains. (Courtesy Muriel Bibeau.)

At some point during this time period, Perry may have constructed a new barn on the property. The locations of earlier outbuildings on the property are unknown. There is no way to know when the barn was built; however, it is certainly 19th-century based on the existing large cut granite stone foundation. The barn is not specifically shown on the 1871 map, however by 1895, a map shows the property in more detail (Figure 3.17). This map shows the Waite-Kirby-Potter house, the house that Restcome built in c1830, and the present barn (Figure 3.18).

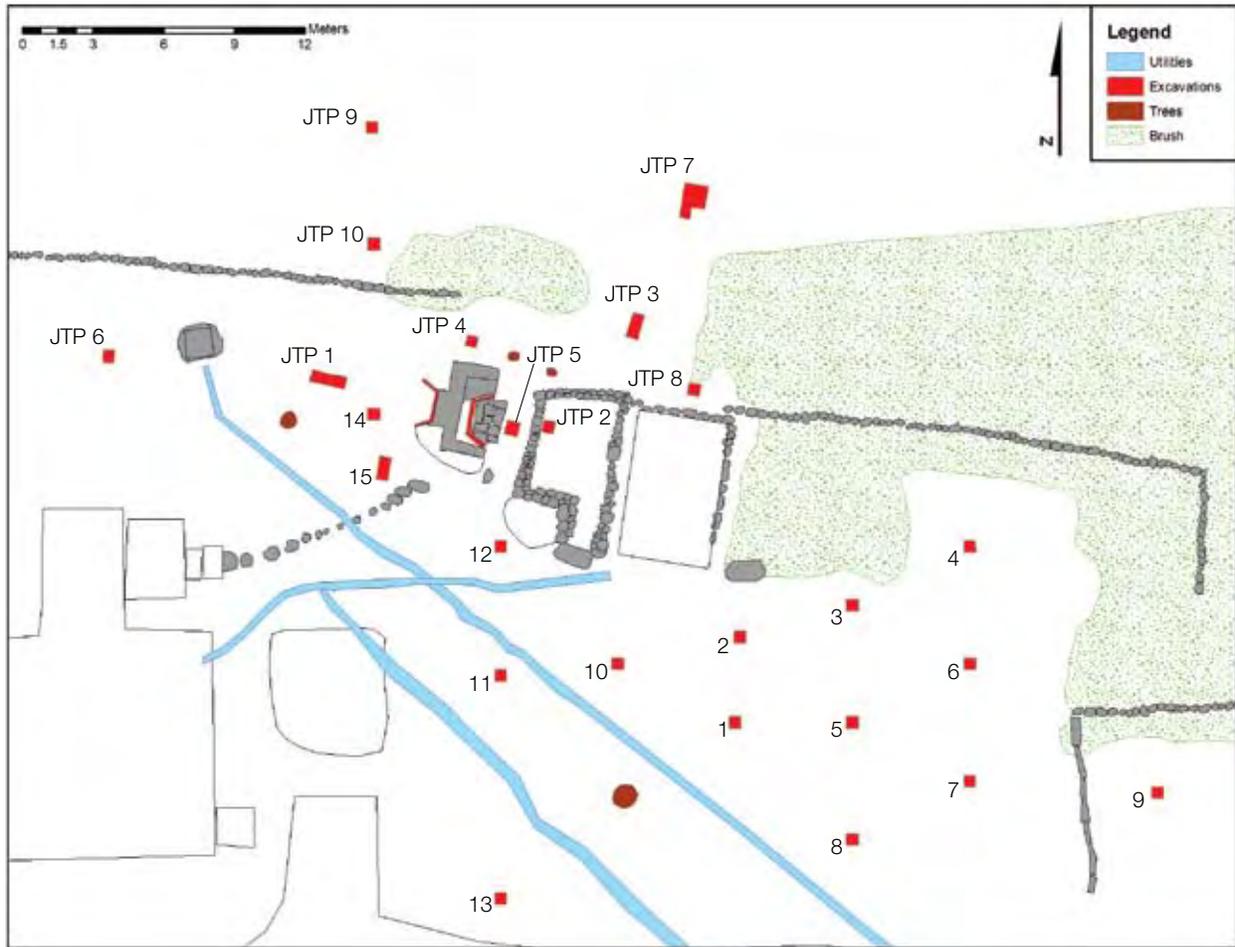
Figure 4.1: Locations of excavation areas.

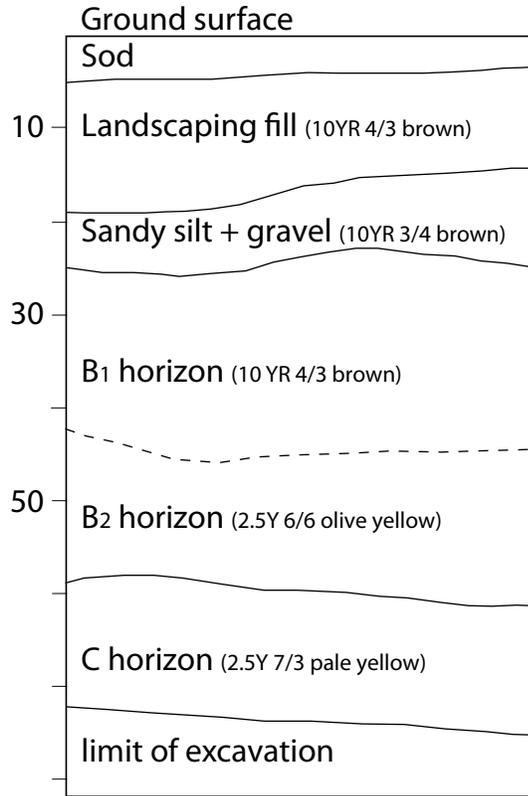
Figure 4.2: Representative profile of STPs in the front yard. The north wall of STP 2 is shown.

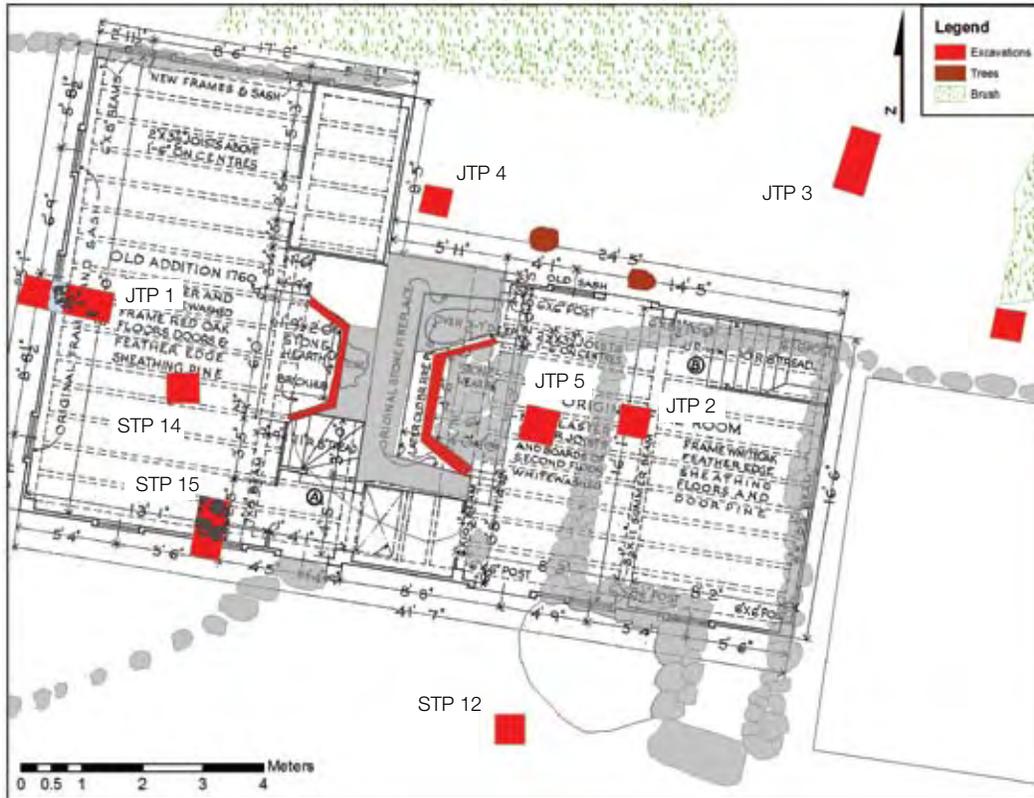
Figure 4.3: Plan of excavation areas near and inside the house with the HABS plan overlain.

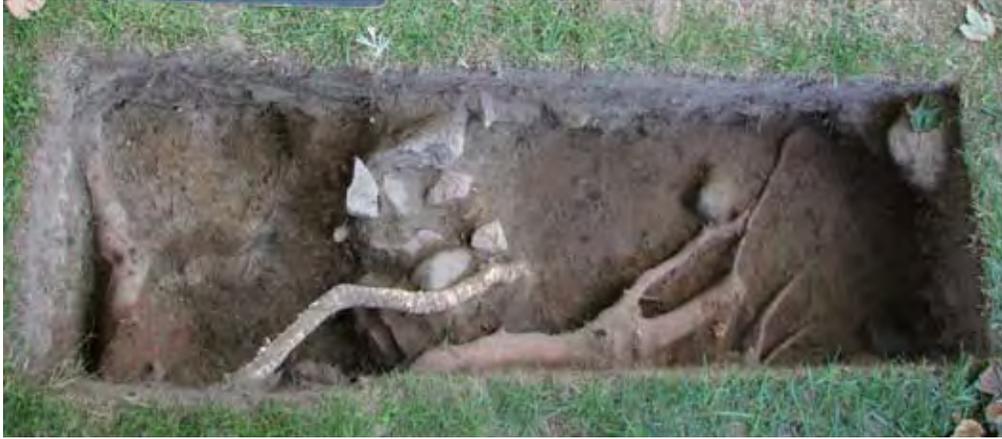
Figure 4.4: West sill support of the western addition in JTP 1, facing north.

JTP 1 was placed to investigate stones visible on the surface that Muriel Bibeau noted were most likely the western edge of the newer portion of the house (added between 1763 and 1793 based on documentary evidence, see Chapter 3). A 1.5 m × 50 cm unit was placed to straddle the possible wall (Figure 4.4). The unit was full of roots from a near by tree and the lower levels were also disturbed by a rodent burrow. The surface stones (Feature 1) did continue below ground; the construction appears to be very simple in that there is no cut, or any large stones. The feature is probably a sill support, rather than a foundation per se and consists purely of small 5-10 cm in diameter stones stacked on and next to one another a few centimeters above the yellowish brown subsoil. A 25 cm section of the stones was removed to examine the layer under the features. The stones rested directly on a thin (4-6 cm) layer of brown sandy silt mottled with black silt and dark yellowish brown silt which covered the whole unit and

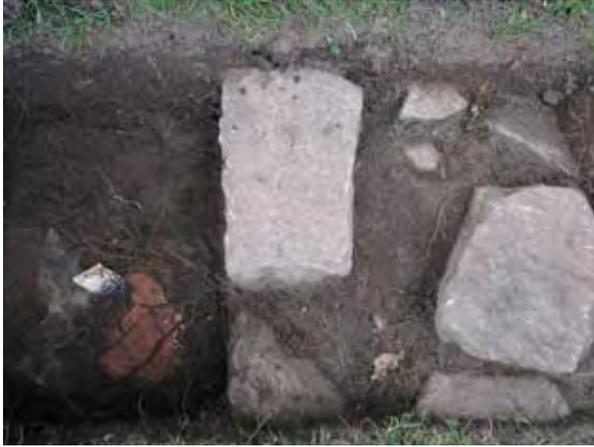
Figures 4.5: In situ ceramics against the exterior of the south foundation wall of the western addition, STP 15. North is to the right.

There was no cellar in this portion of the house, and it is likely that the addition consisted of a wooden sill joined to posts the rested on stone corner stone piers or set directly into the ground with smaller stones underneath the sills. This construction method would have protected the sills from rot and helped to seal the area underneath the floor from rodents. Immediately outside the sill support were the shallow remains of a post hole (Feature 2). This hole was 30 cm in diameter, but only a few centimeters of its fill remained.

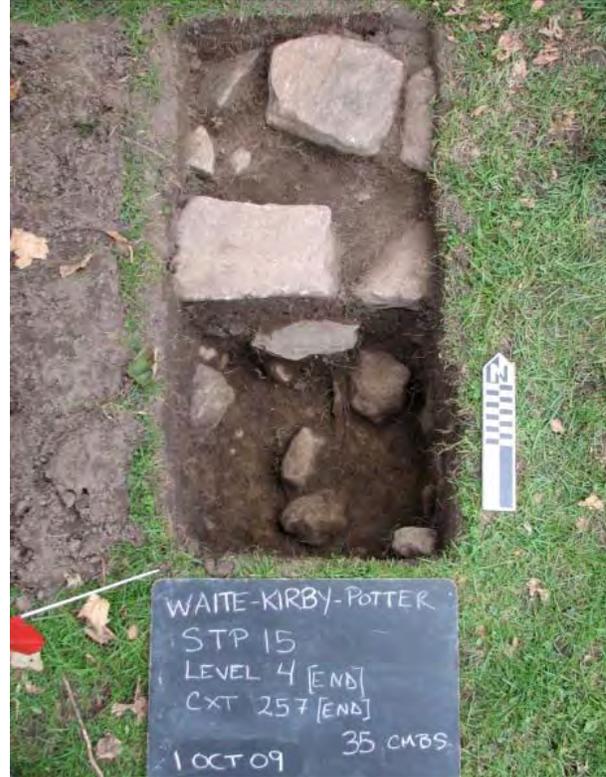
Figure 4.6: STP15 at the end of excavation.

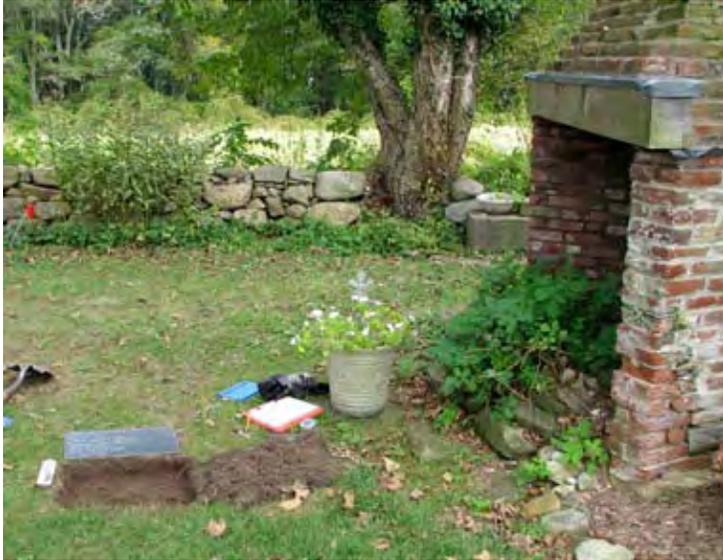
Figure 4.7: STP 14 inside the western addition, during excavation, facing north.

STP 14 was excavated directly west of the brick fireplace (Figure 4.7), in what would have been the interior of the western addition. Since there was no cellar in this part of the house, it was thought that perhaps there might be earlier deposits that had been capped by the 18th-century addition. Although no such deposit was found, the test pit was artifact-dense, likely from objects falling through cracks in the floorboards. The unit was excavated to the depth of 45 cmbs in three strata: topsoil (0-17 cm) which contained most of the artifacts, a mottled level containing charcoal flecks which might have been the old ground surface or the surface under the floorboards (17 to 27 cmbs), and a rapid transition to gravelly, yellowish brown subsoil (excavated to 45 cmbs). Again, most of the artifacts were architectural (nails, window glass, and construction materials). A silver plated spoon marked “Rogers Bros” of an inexpensive pattern manufactured between 1879 and 1915 and

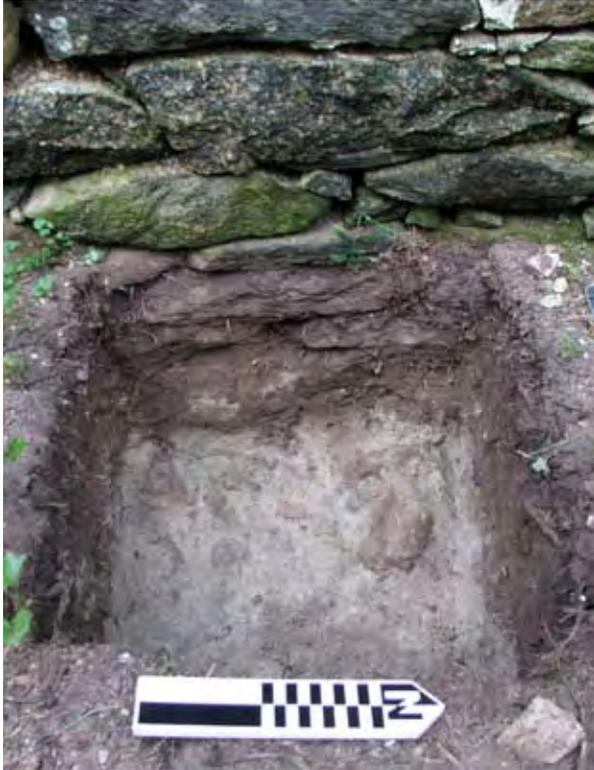
Figure 4.8: JTP 2 at the end of the cultural layers.

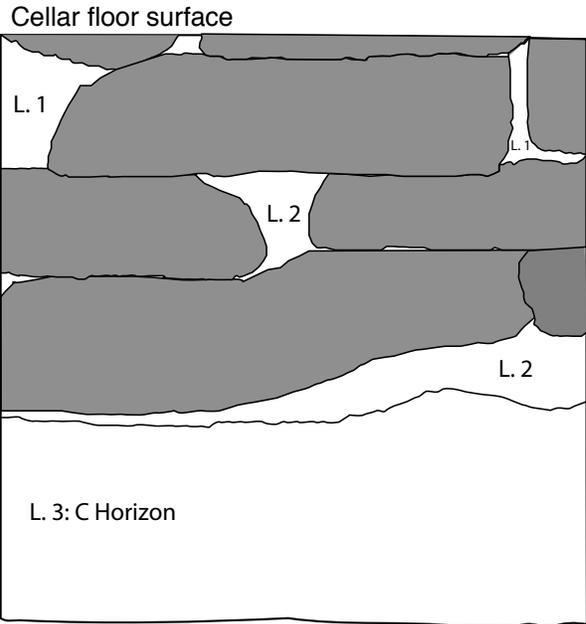
Figure 4.9: West profile of JTP 2 showing cellar wall construction and stratigraphy of the cellar floor.

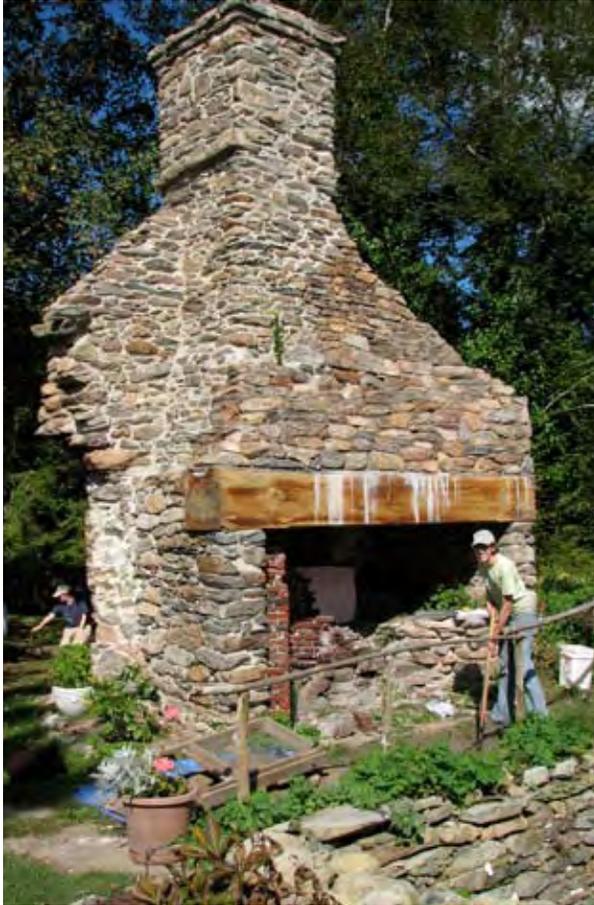
Figure 4.10: Excavation of JTP 5 in progress, facing northwest.

JTP 5 was excavated just to the west of the cellar hole in what would have been the interior of the stone end house. The unit was located between the cellar and the hearth stones of the stone fireplace (Figure 4.10). Although no distinct living surface was found, the top layer which extended to 25 cm below surface had a large amount of architectural debris including bricks marked “B B Co.” Mottling with the 10YR 5/6 yellowish brown subsoil began at approximately 35 cm below surface. Artifacts continued into the subsoil, and this is most likely due to the heavily bioturbated strata by roots and large glacial boulders. The eastern side of the test pit revealed stacked stones, which may be the western side of the cellar wall. This suggests that the hole for the cellar was dug first, and then lined with stones.

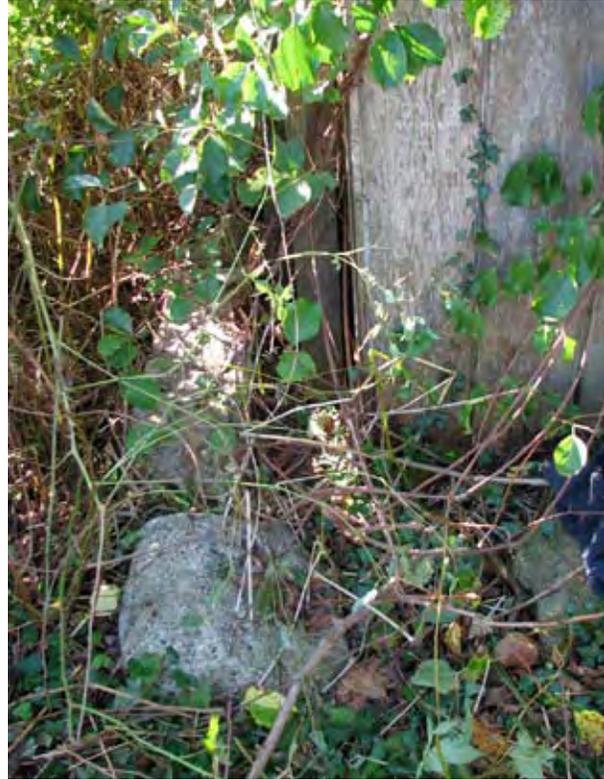
Figure 4.11: Foundation stones for previous shed just outside the northwest corner of the modern shed.

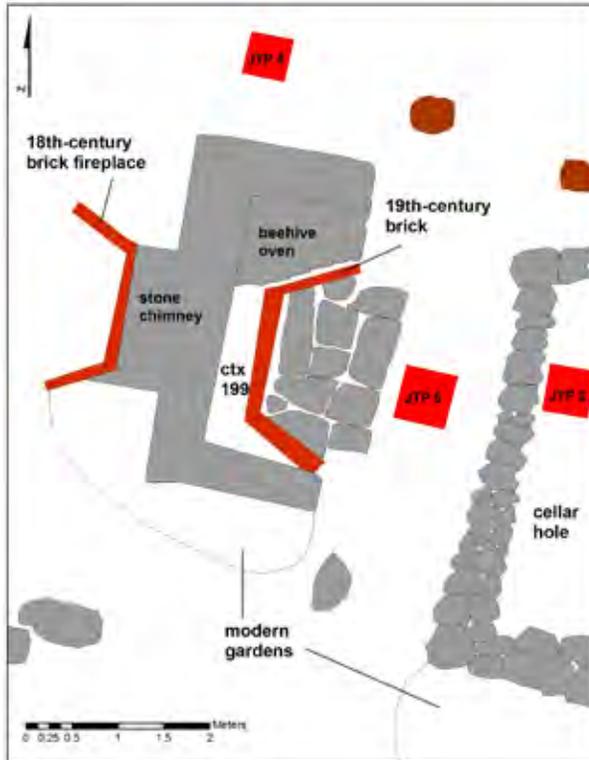
Figure 4.12: Plan of the chimney complex, showing elements from different time periods. North is to the top.

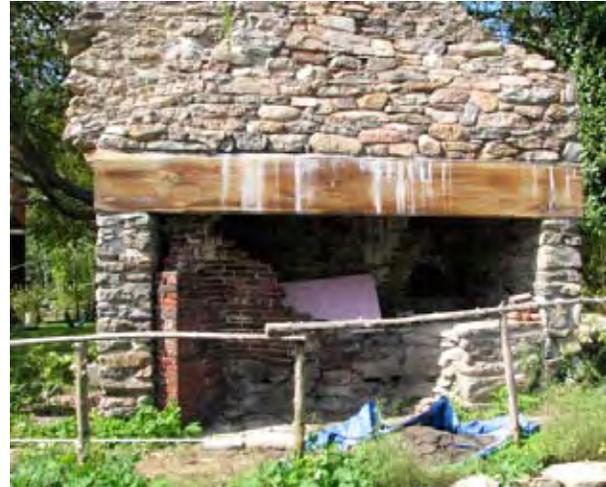
Figure 4.13: The current condition of the east side of the stone chimney with restored stonework and lintel and decaying later brick firebox, facing west.

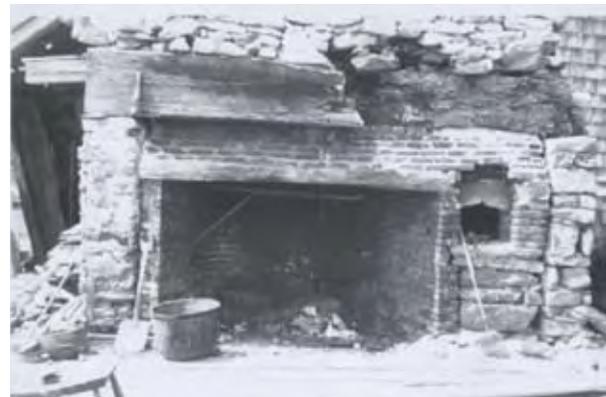
Figure 4.14: Historical photograph of the stone chimney, facing west, with intact smaller brick firebox and bake oven, date unknown, but post 1954. Courtesy of Muriel Bibeau.

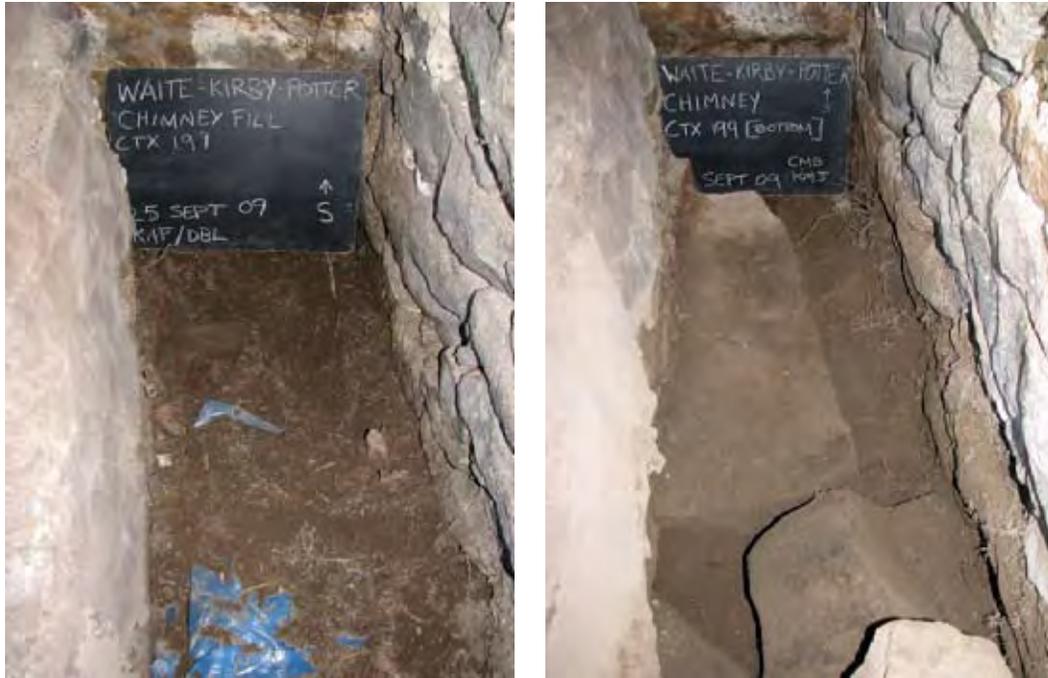
Figure 4.15: Context 199 inside the chimney at the beginning and end of excavation. The opening photograph shows the blue tarp left during the chimney restoration.

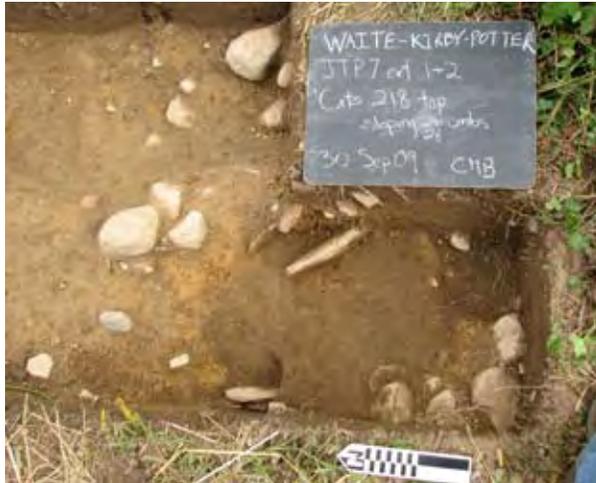
Figure 4.30: JTP 7 showing the top of one post hole feature. Note the vertical granite spalls in the hole, presumably to help hold the post upright.

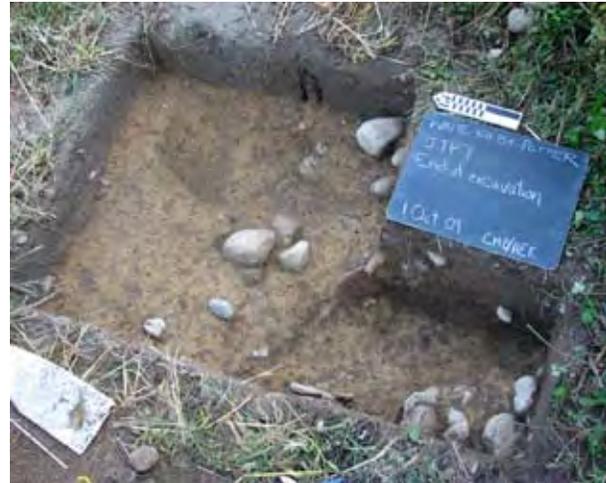
Figure 4.31: JTP 7 at the end of excavation. One excavated posthole is visible in the northeast of the unit, another in the southwest, while the edge of a third post hole is just visible in the southeast corner of the extension.

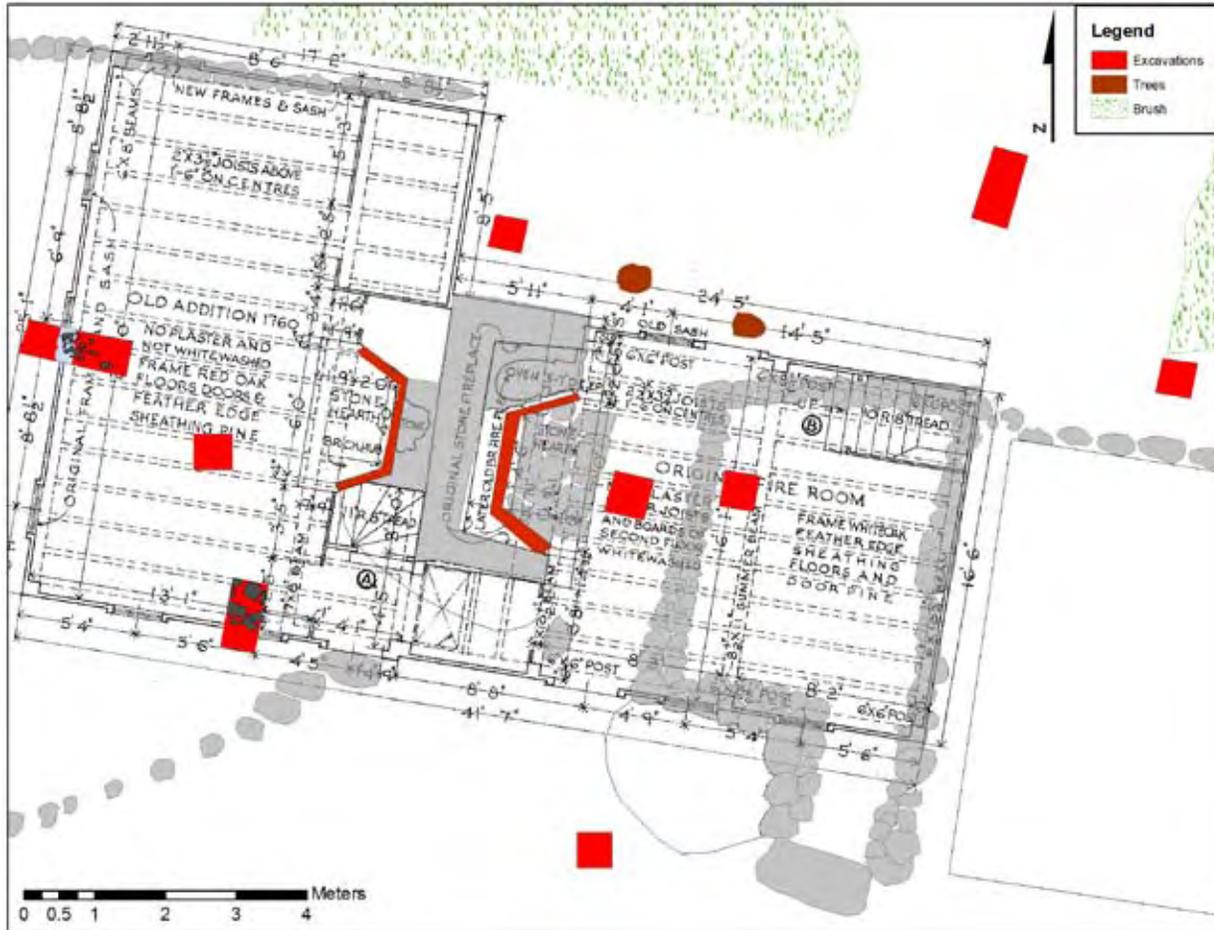
Figure 5.2: The HABS plan of the Waites-Kirby-Potter house superimposed on the map of the cellar hole.

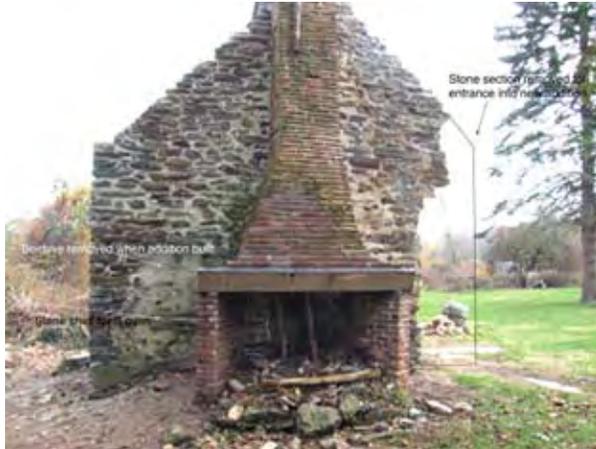
Figure 5.3: Anne Baker's annotated photograph of the west side of the stone chimney showing evidence of the original beehive oven (Courtesy of Anne Baker, 2009).

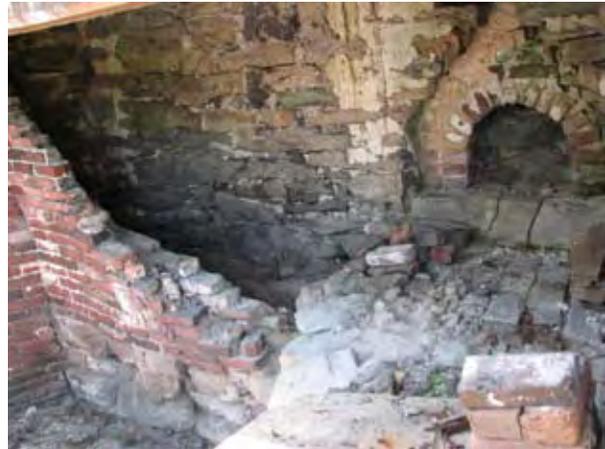
Figure 5.4: The opening for the original bake oven behind the later brick firebox insert in the east hearth.
